Avian Mortality at Solar Energy Facilities in Southern California: A Preliminary Analysis

Rebecca A. Kagan, Tabitha C. Viner, Pepper W. Trail, and Edgard O. Espinoza
National Fish and Wildlife Forensics Laboratory

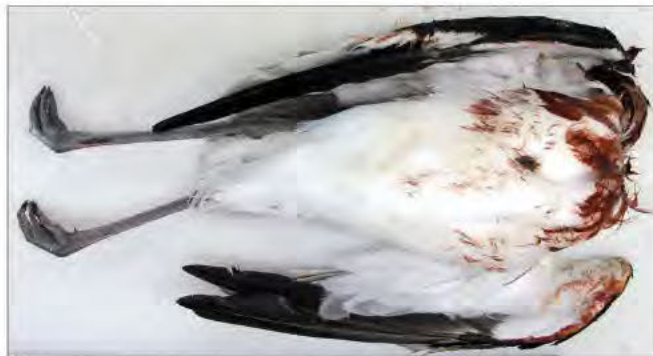
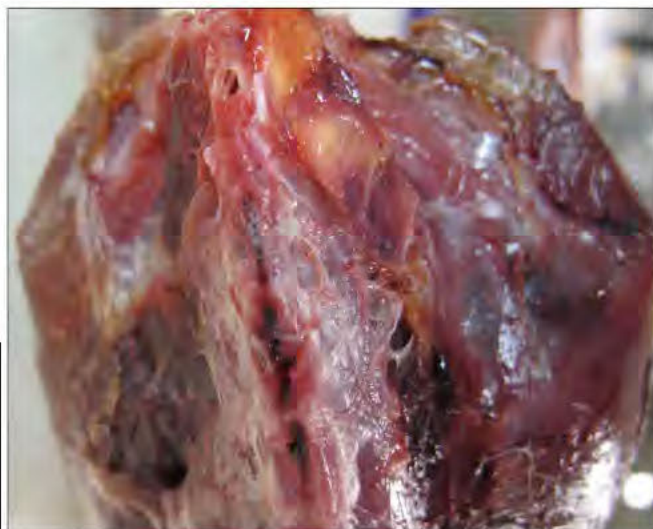
Figure 2: Predation trauma (top) resulting in traumatic amputation of the head and neck (American Avocet) and impact trauma (bottom) causing bruising of the keel ridge of the sternum (Brown Pelican).

Blunt force impact trauma was determined to have been the cause of death for 19 Desert Sunlight birds including two Western Grebes (*Aechmophorus occidentalis*) and one each of 16 other species. Impact (blunt force) trauma is diagnosed by the presence of fractures and internal and/or external contusions. In particular, bruising around the legs, wings and chest are consistent with crash-landings while fractures of the head and/or neck are consistent with high-velocity, frontal impact (such as may result from impacting a mirror).

Predation was the immediate cause of death for 15 birds. Lesions supporting the finding of predation included decapitation or missing parts of the body with associated hemorrhage (9/15), and lacerations of the skin and pectoral muscles. Eight of the predated birds from Desert Sunlight were

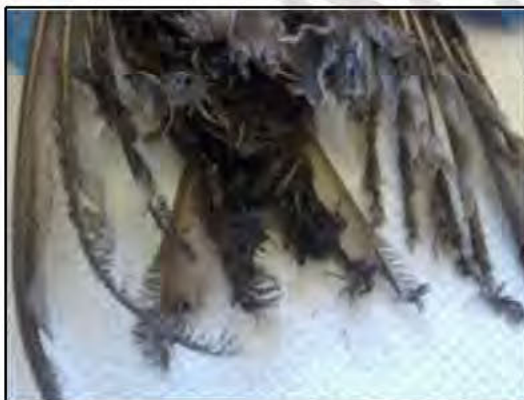
Figure 10: Singed feathers from a Northern Rough-winged Swallow

Many of the carcasses recovered from the Ivanpah Solar plant after the plant became operational showed singeing of feathers as shown in Figure 10.
